HARFORD COUNTY DPW

UPPER FARNANDIS SMALL WATERSHED ASSESSMENT REPORT

APRIL 02, 2018

HARFORD COUNTY DEPARTMENT OF
PUBLIC WORKS

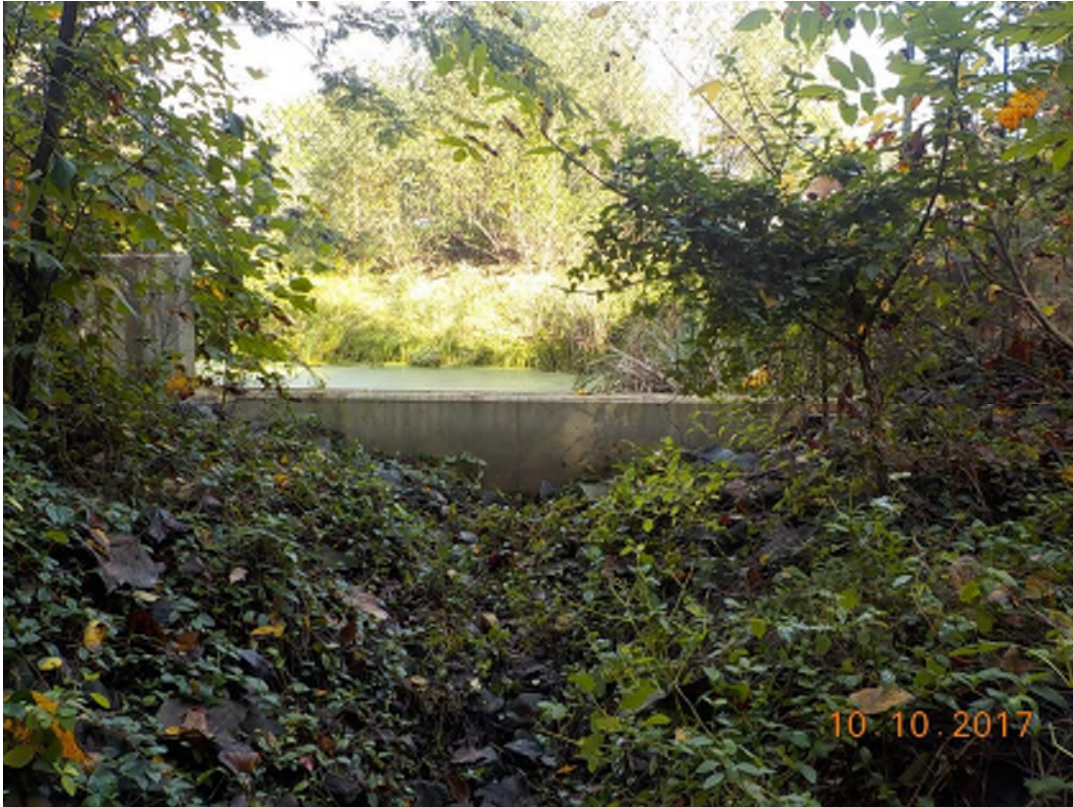
Figure 3: Outfall 38 conveys overflow from existing BMP 10 (Figure 1) to left bank of tributary 1. Weir outfall and 3-inch orifice approximately 30 feet from tributary 1.

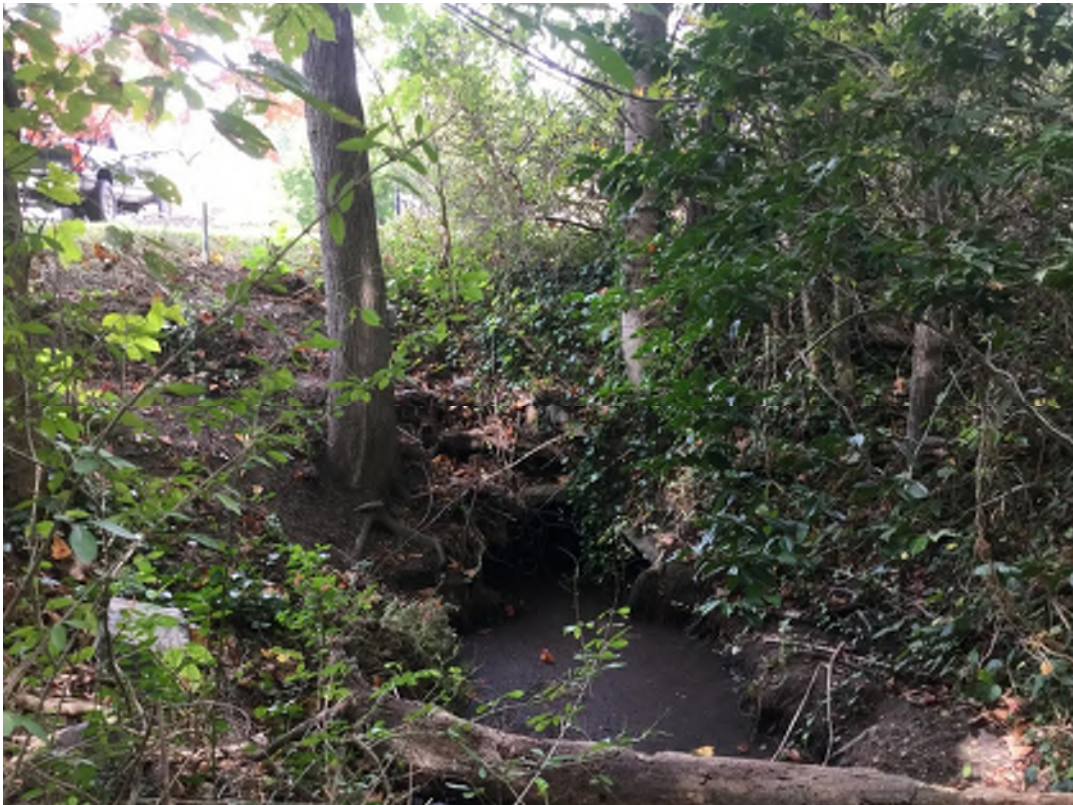
Figure 6: Outfall 18 is elliptical concrete pipe entering left bank of tributary 1. Outfall is approximately 129 feet from the stream.

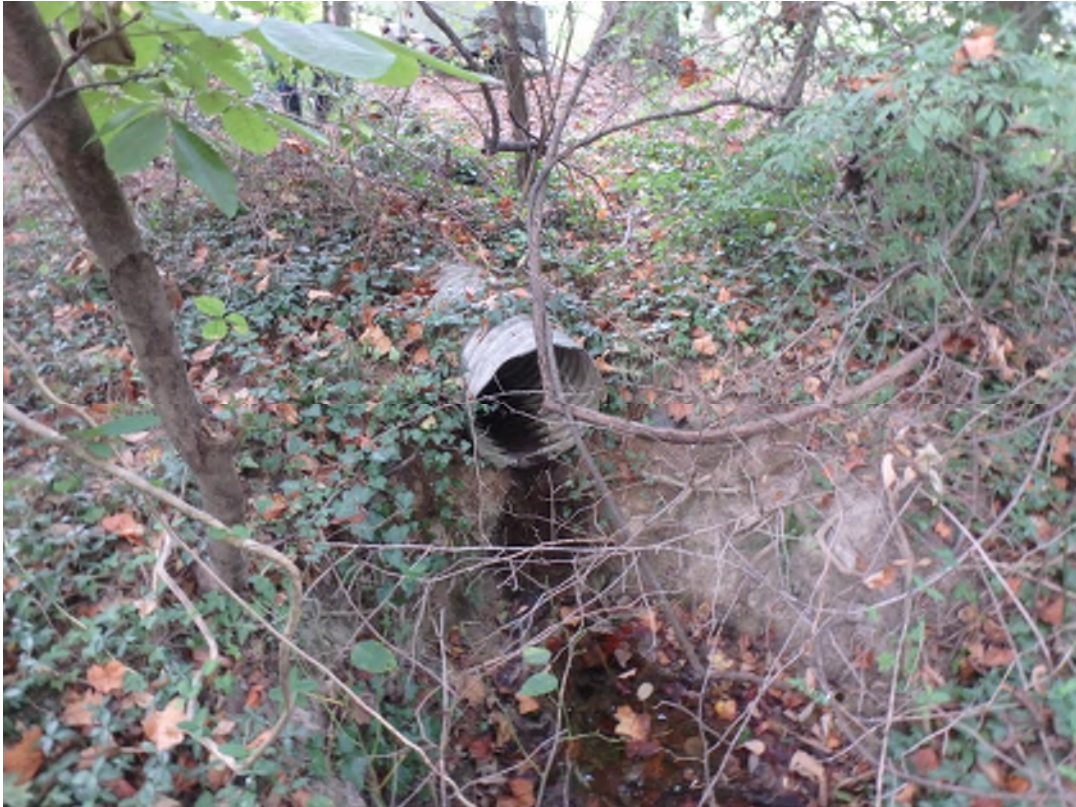
Figure 7: Outfall 23 is an 18" corrugated metal pipe on the left bank of tributary 1. Outfall is approximately 7 feet from stream.

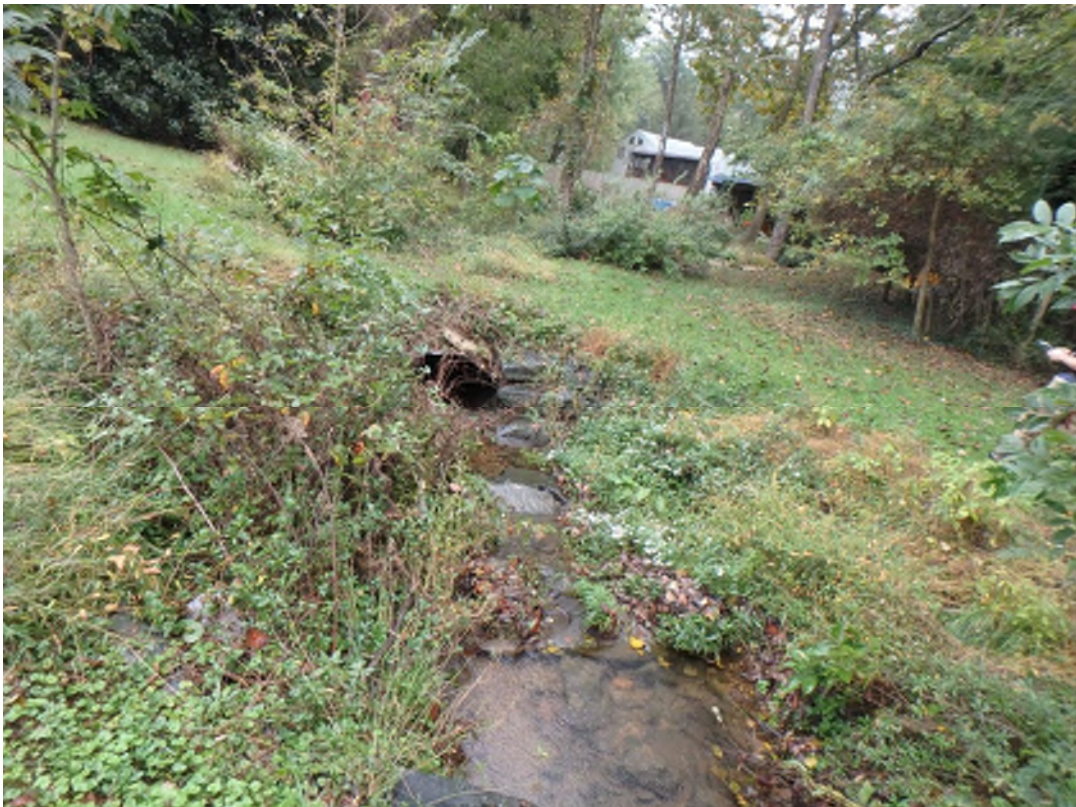
Figure 8: Corrugated metal pipe conveys flow in channel in tributary 1.

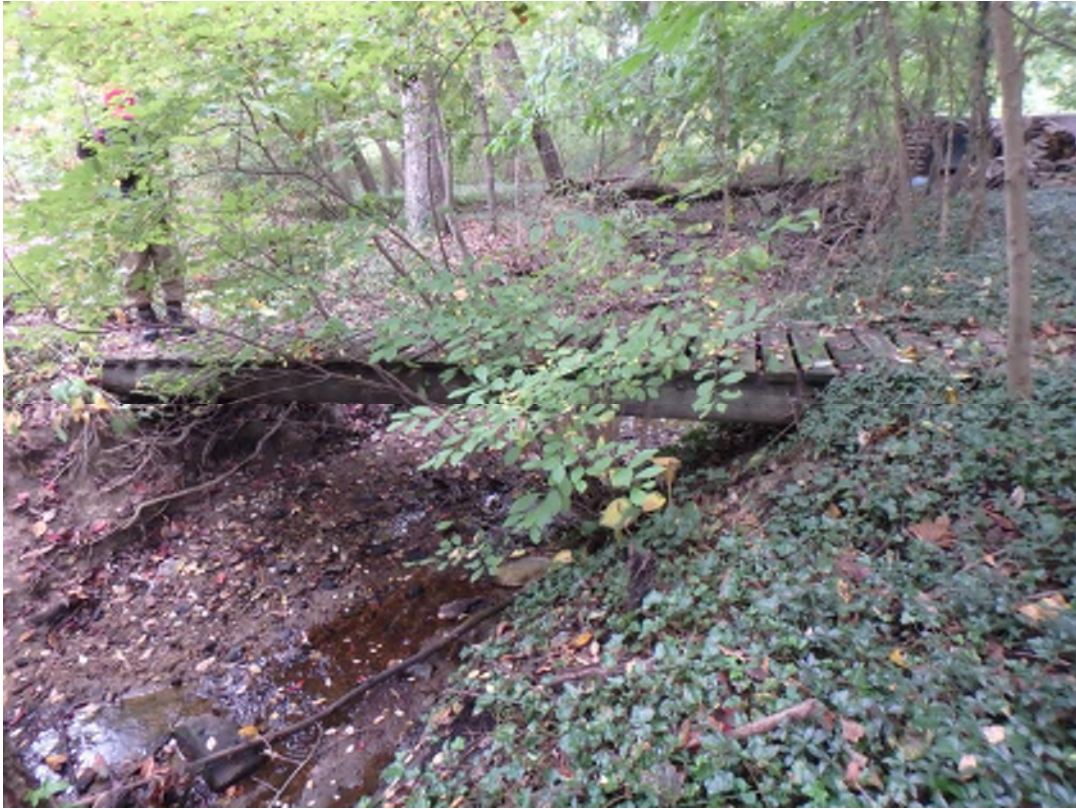
Figure 9: Wooden bridge crossing over tributary 1.

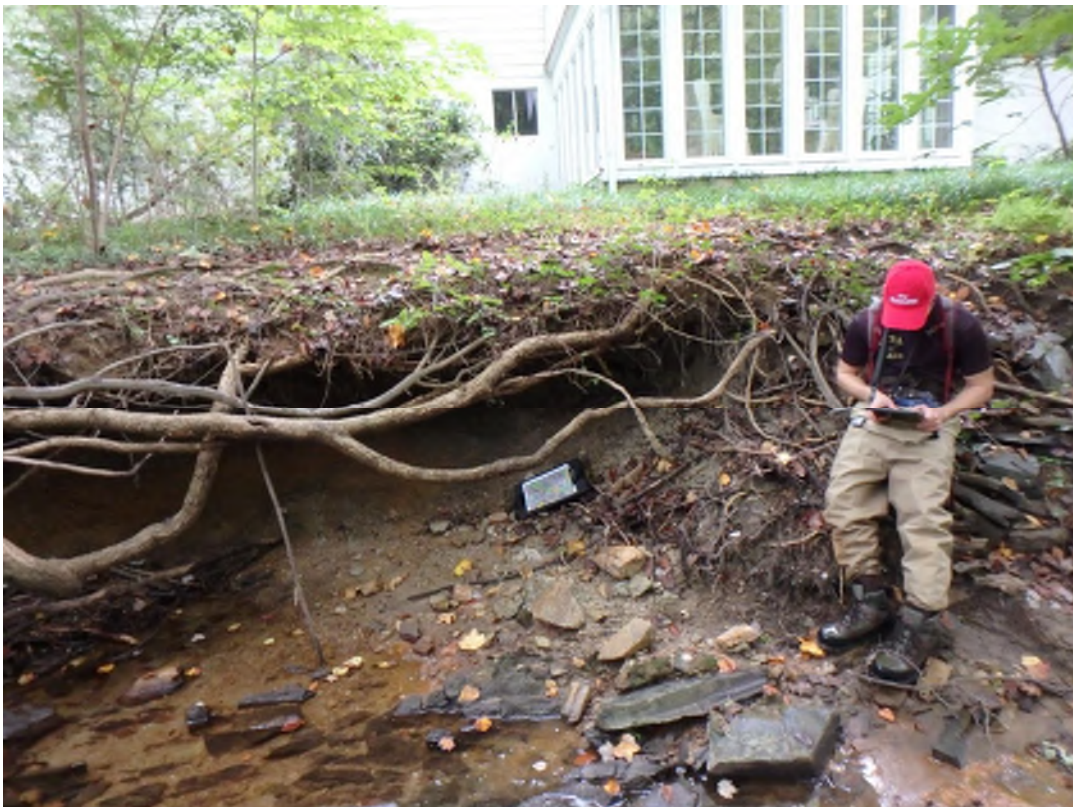
Figure 11: Severely undercut bank in tributary 1.

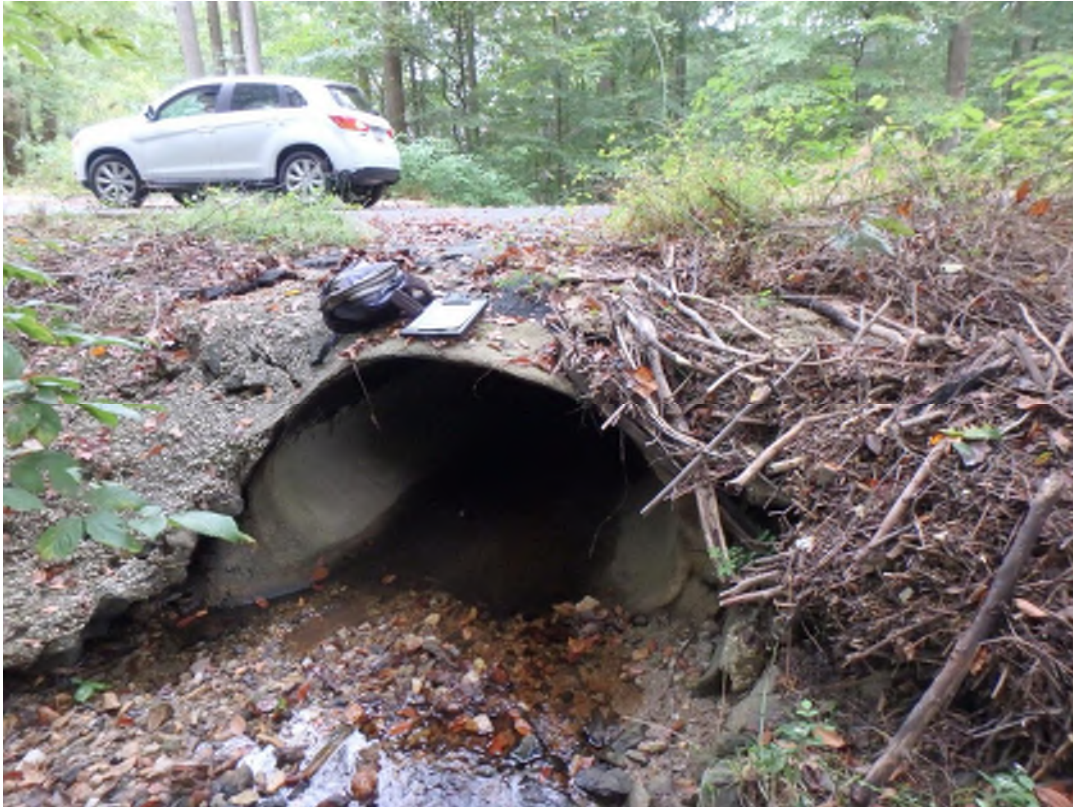
Figure 12: Culvert conveys tributary 1 flow under Wakely Terrace just upstream of confluence with Macphail subwatershed.

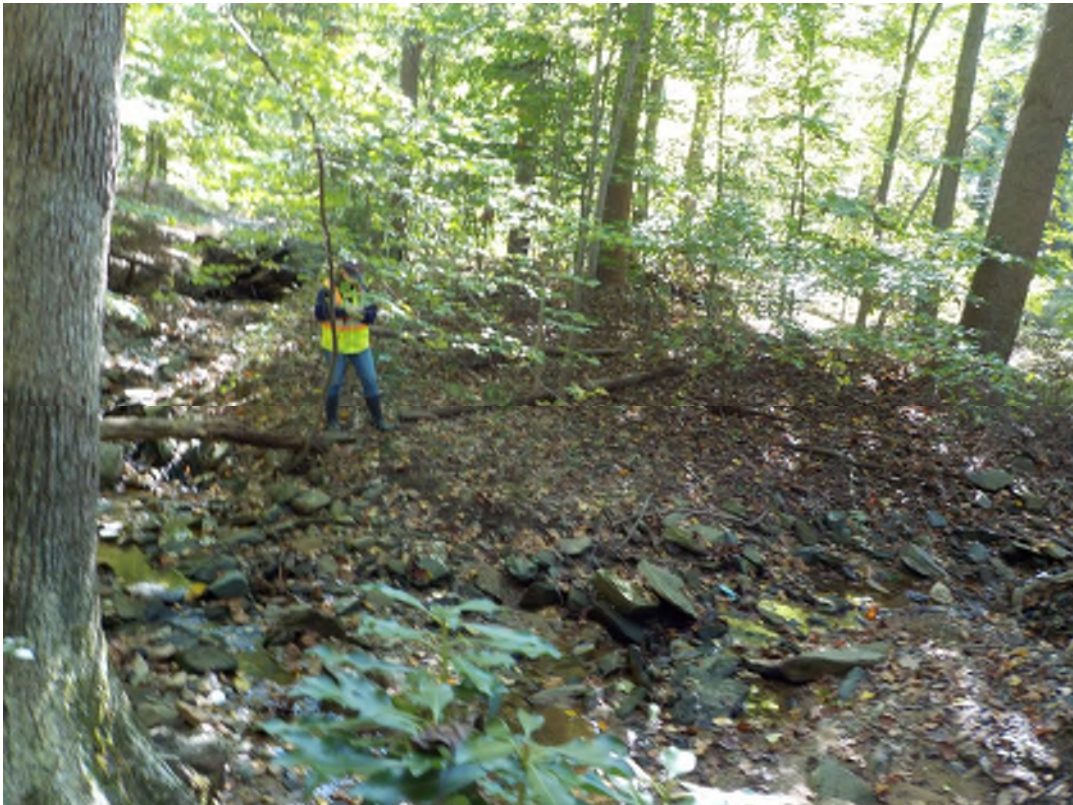
Figure 13: Confluence of Macphail subwatershed (right) with Victory subwatershed (left) at entrance to Grosvenor subwatershed.

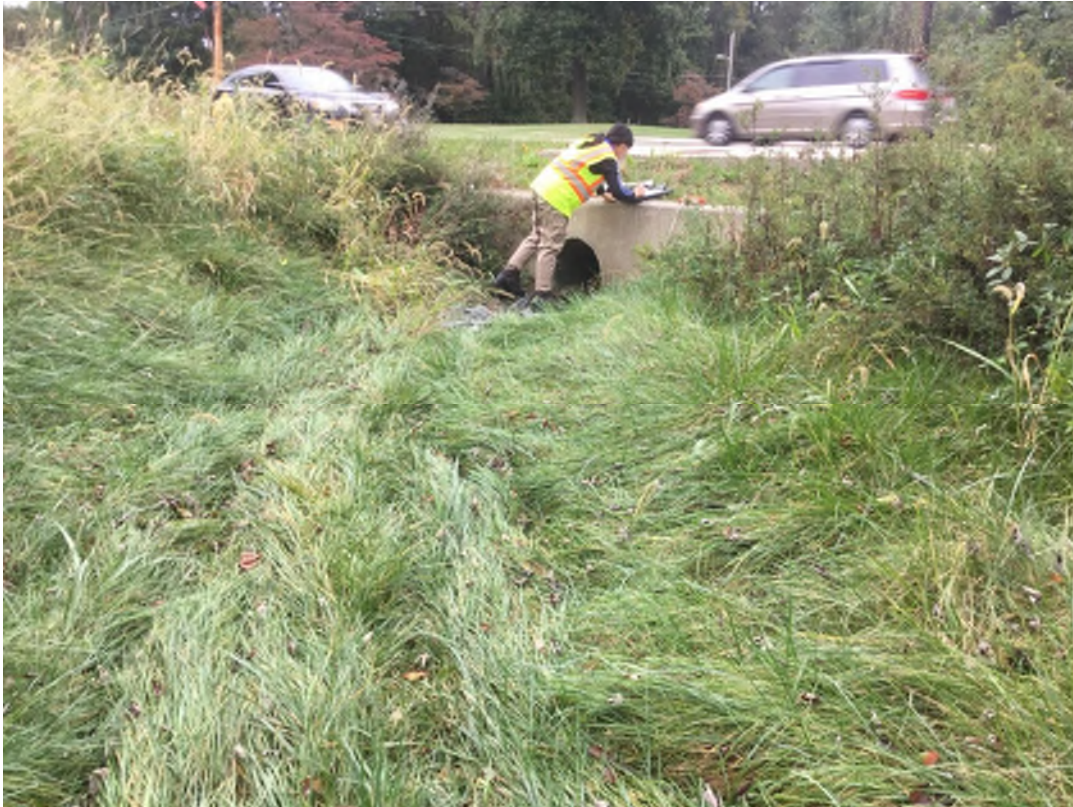
Figure 14: Outfall 17 conveys drainage via grass ditch to follow existing drainage network to outfall 39 (Figure 15).

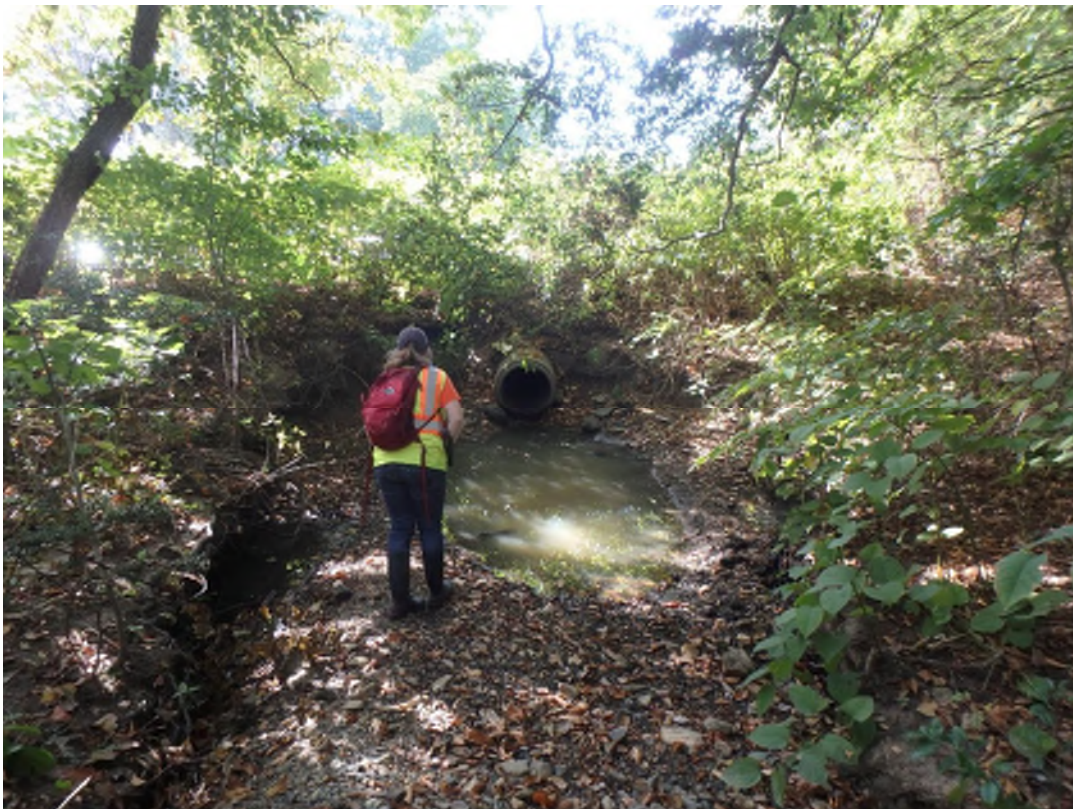
Figure 15: Outfall 39 conveys flow to tributary 2 from upstream drainage network via 30-inch concrete pipe. Outfall channel splits and has multiple connections to right bank of tributary 1. Outfall is approximately 117 feet from tributary 1.

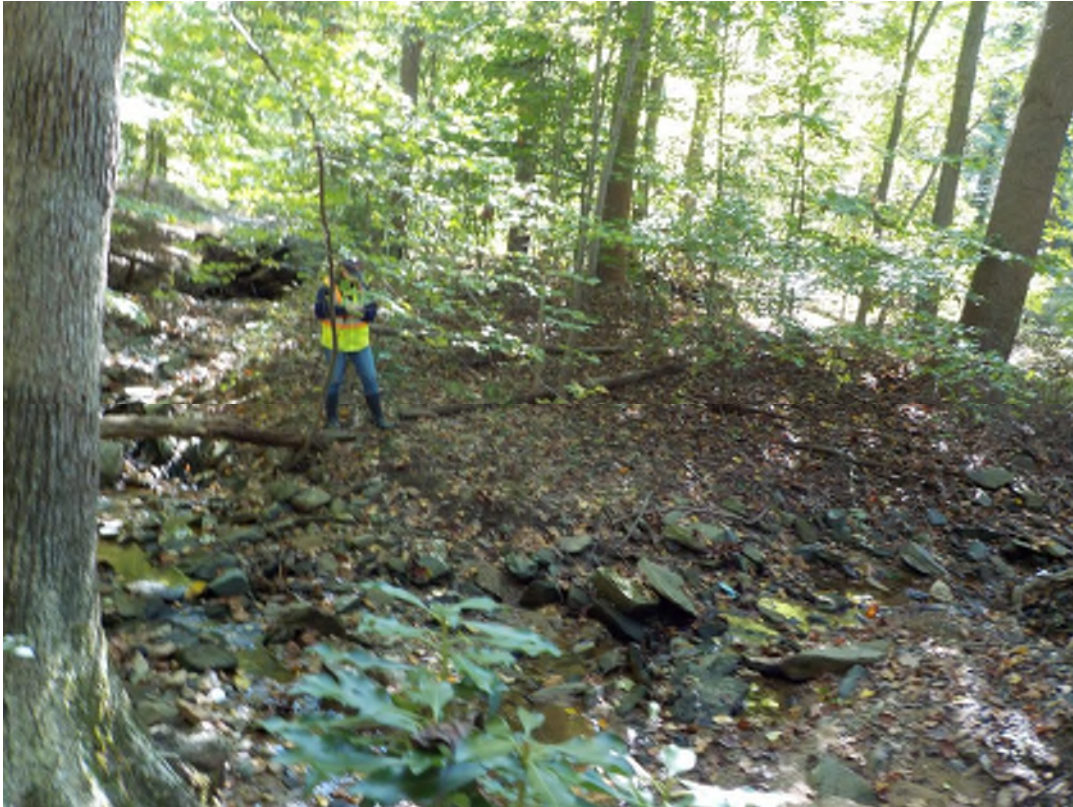
Figure 1: Confluence of Macphail subwatershed (right) with Victory subwatershed (left) at beginning of Grosvenor subwatershed.

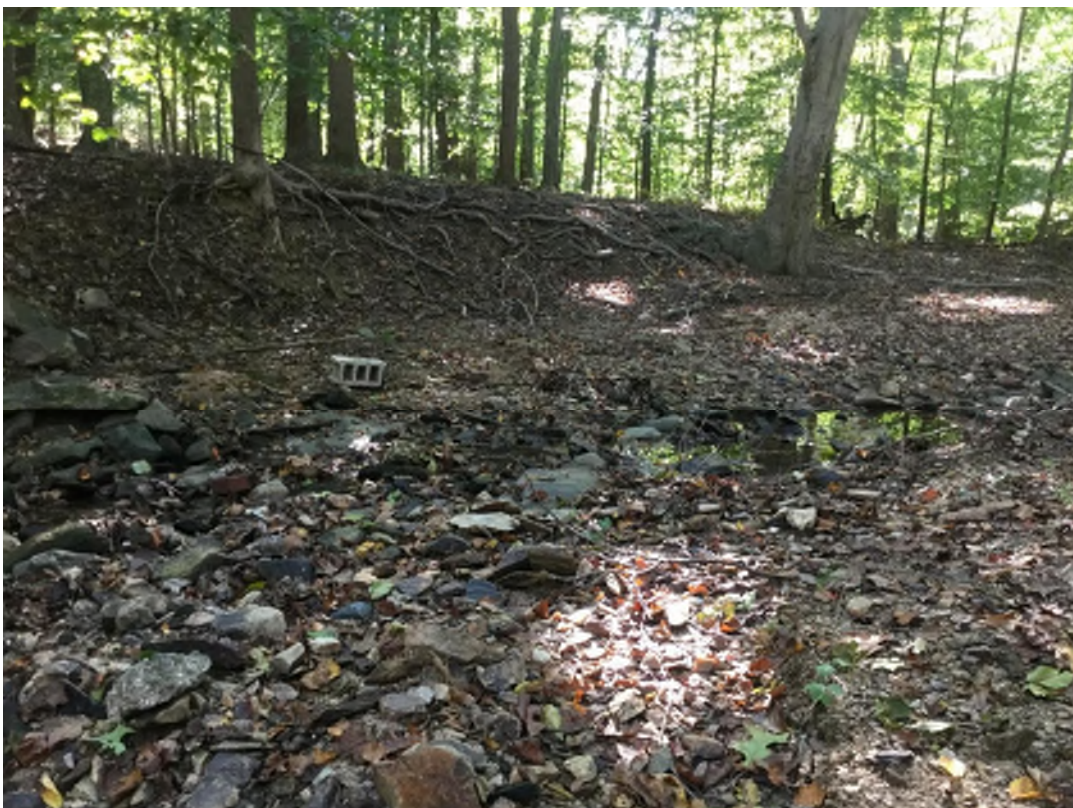
Figure 2: Tributary 1 bank erosion upstream of confluence with tributary 2. Channel is wide in this portion of stream.

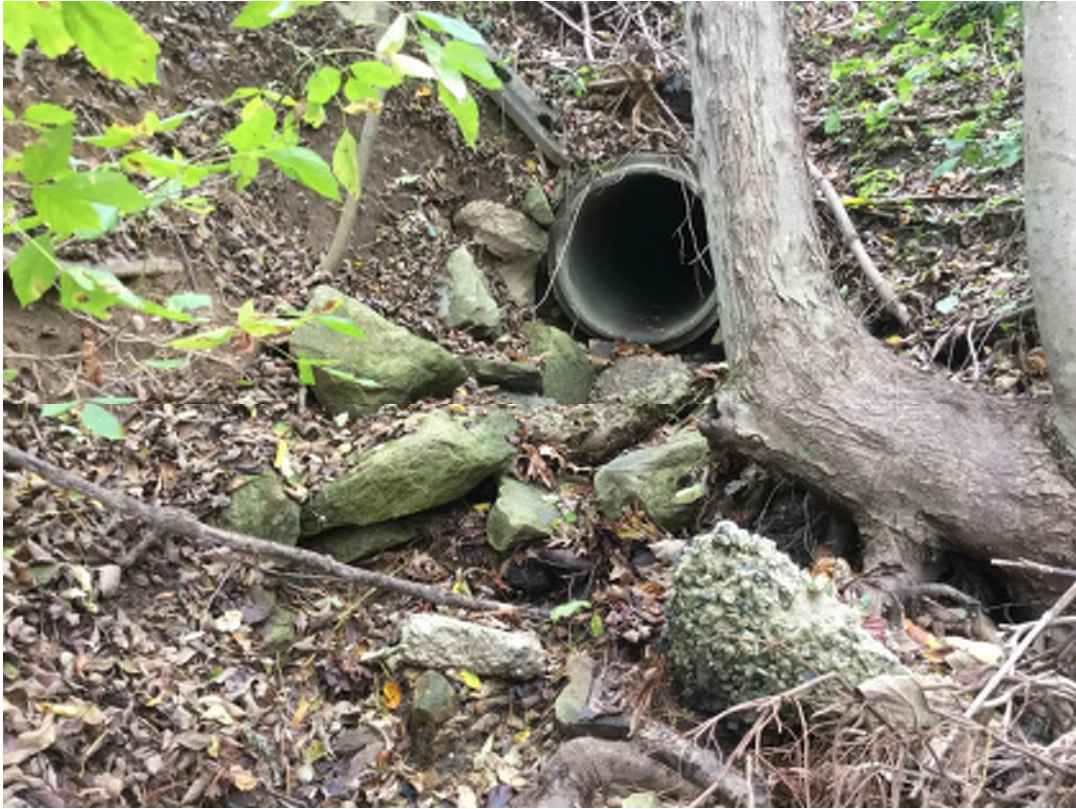
Figure 3: Outfall 2 is a 30-inch concrete pipe conveying flow at the head of tributary 2. Outfall is approximately 495 feet to channel and has 430 feet of riprap outfall protection.

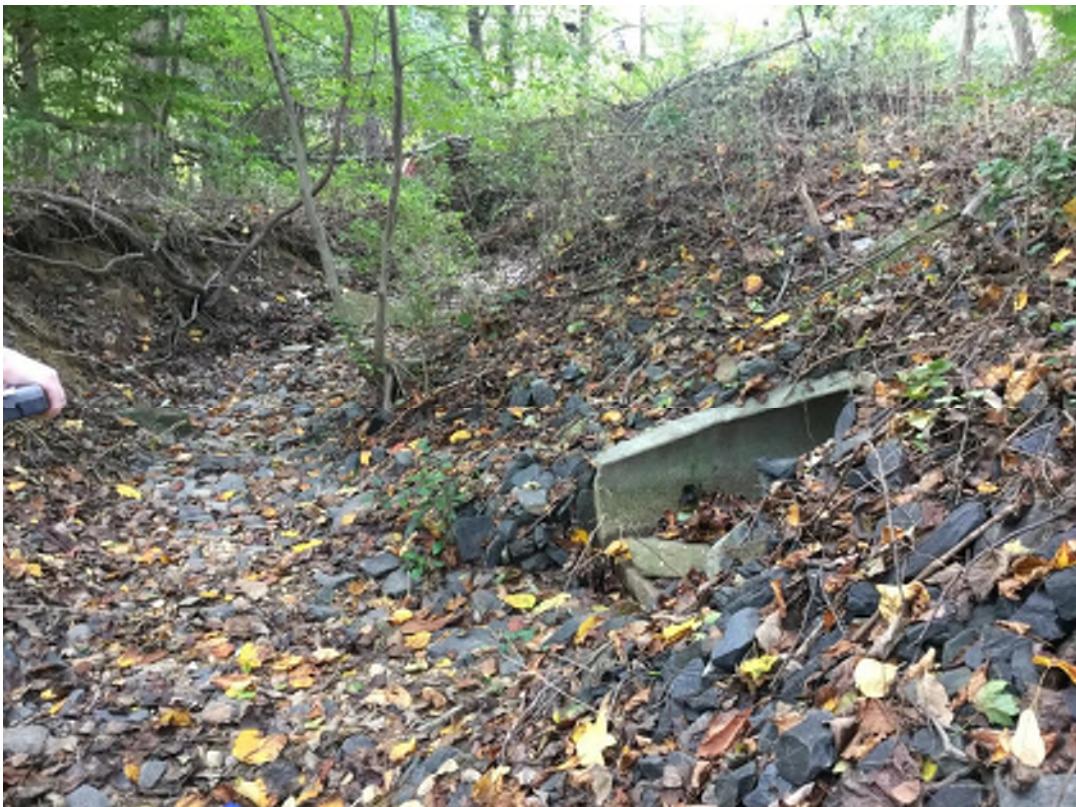
Figure 4: Outfall 3 is an 18-inch concrete pipe conveying flow to the right bank of the outfall protection riprap channel of outfall 2 (Figure 3). Photo is looking downstream on outfall 2 riprap channel.

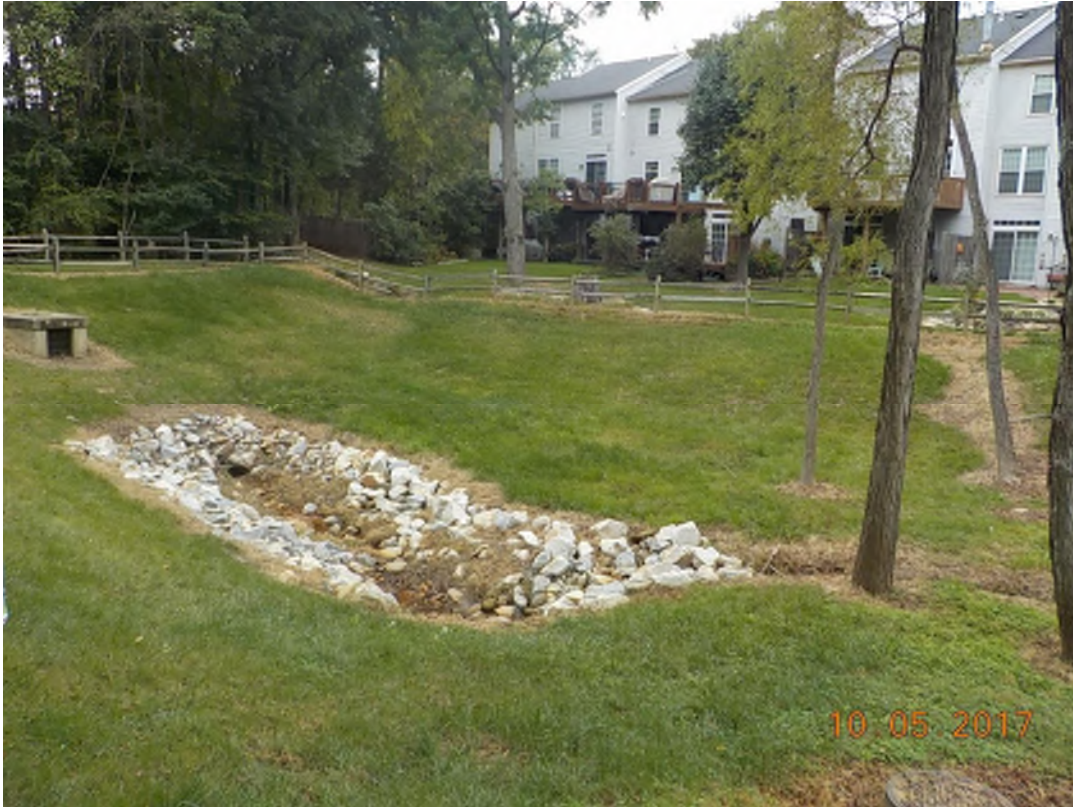
Figure 5: Existing BMP 3 is an extended detention basin. A wet pond retrofit to the facility is proposed. Flow from outfall 2 (Figure 3) and outfall 3 (Figure 4) enters facility.

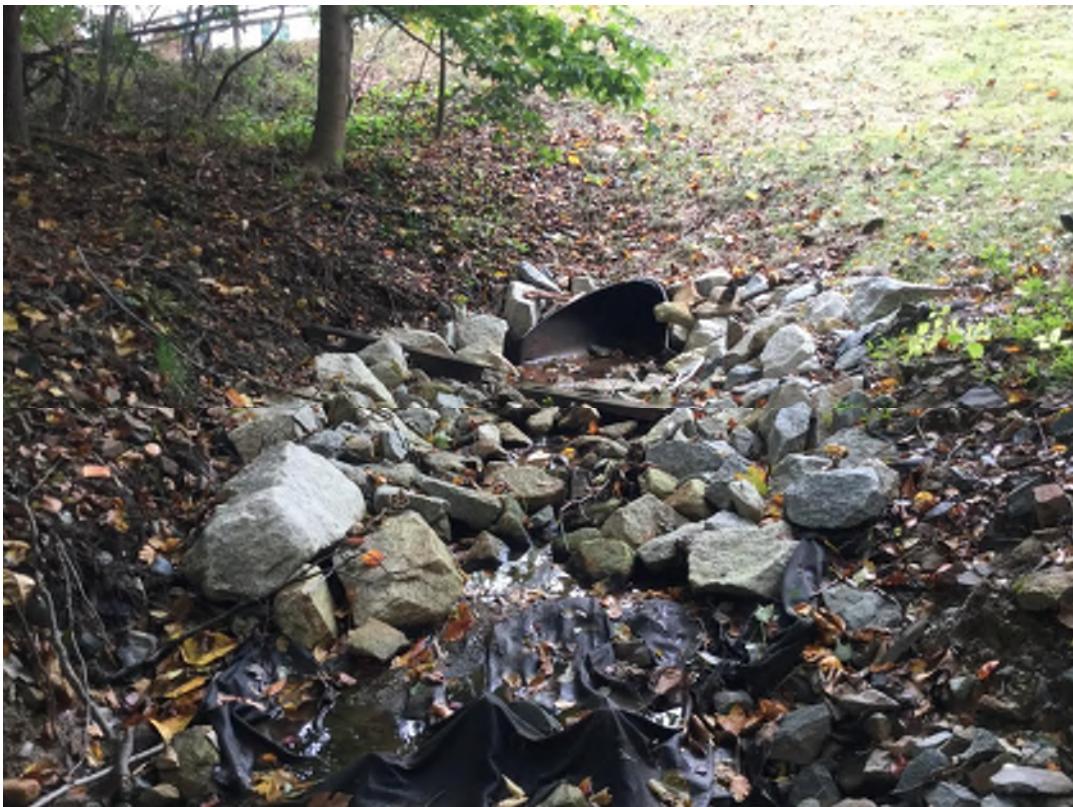
Figure 6: Outfall 4 is a 24-inch metal pipe conveying flow from existing BMP 3 (Figure 5) to the headwaters of tributary 2 in the subwatershed. A 49-foot riprap channel exists as outfall protection.

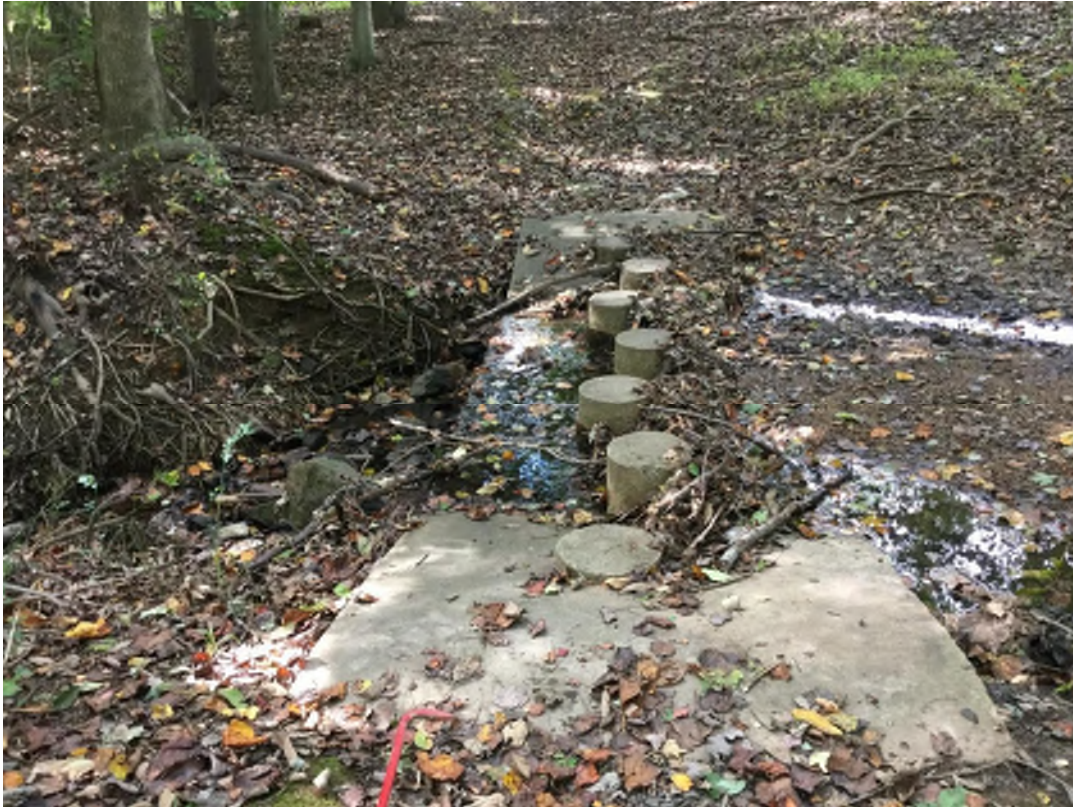
Figure 7: Concrete weir channel alteration downstream of outfall 4 in tributary 2.

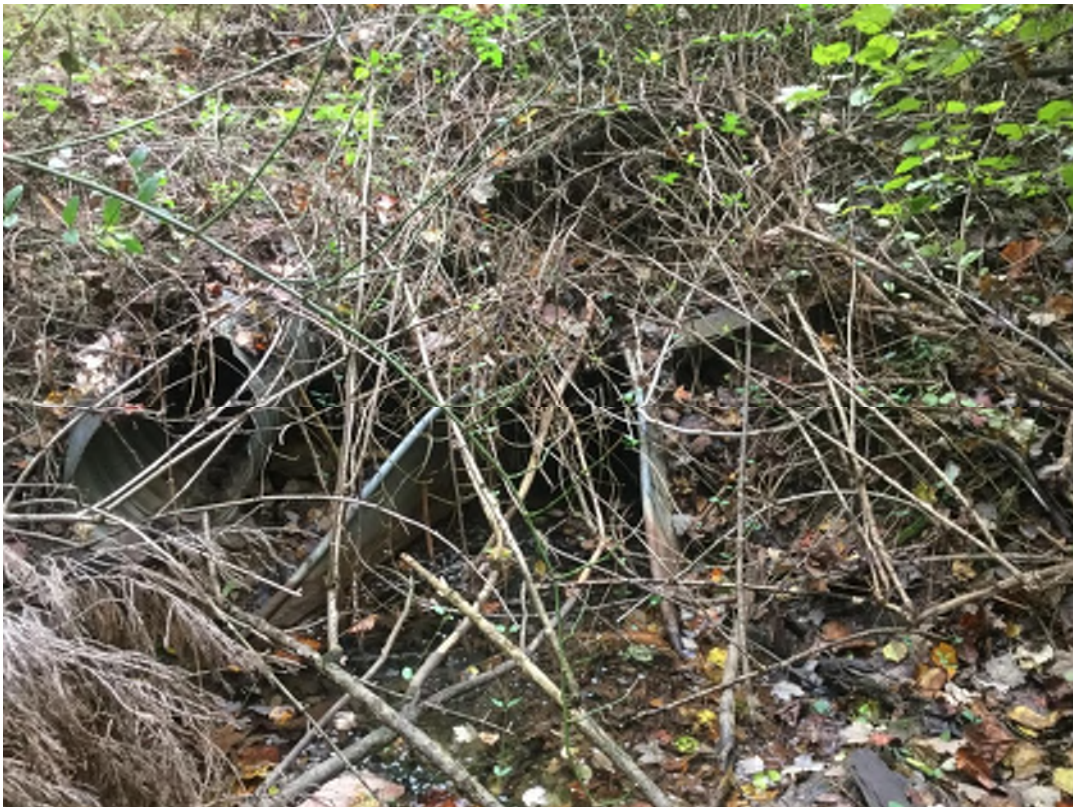
Figure 8: Outfall 21 is a 24-inch metal pipe at the head of tributary 3. Outfall is 179 feet from right bank of tributary 2. Erosion present in outfall channel.

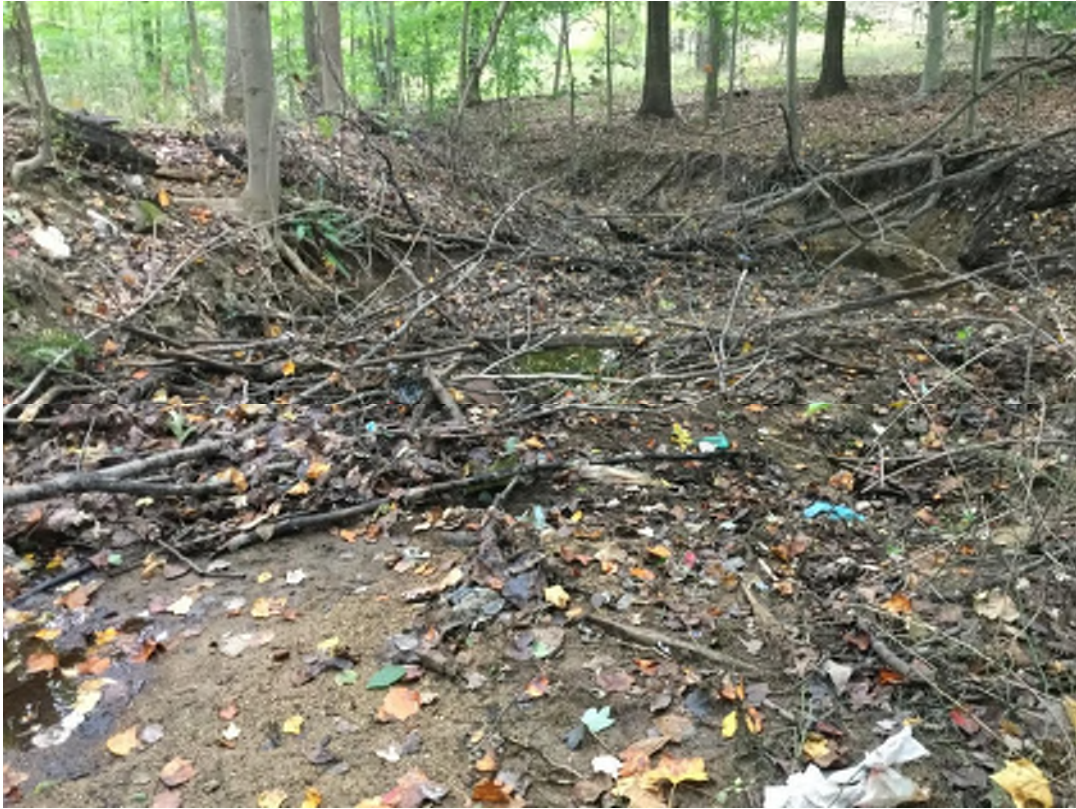
Figure 9: Confluence of tributary 3 (left) with tributary 2 (right).

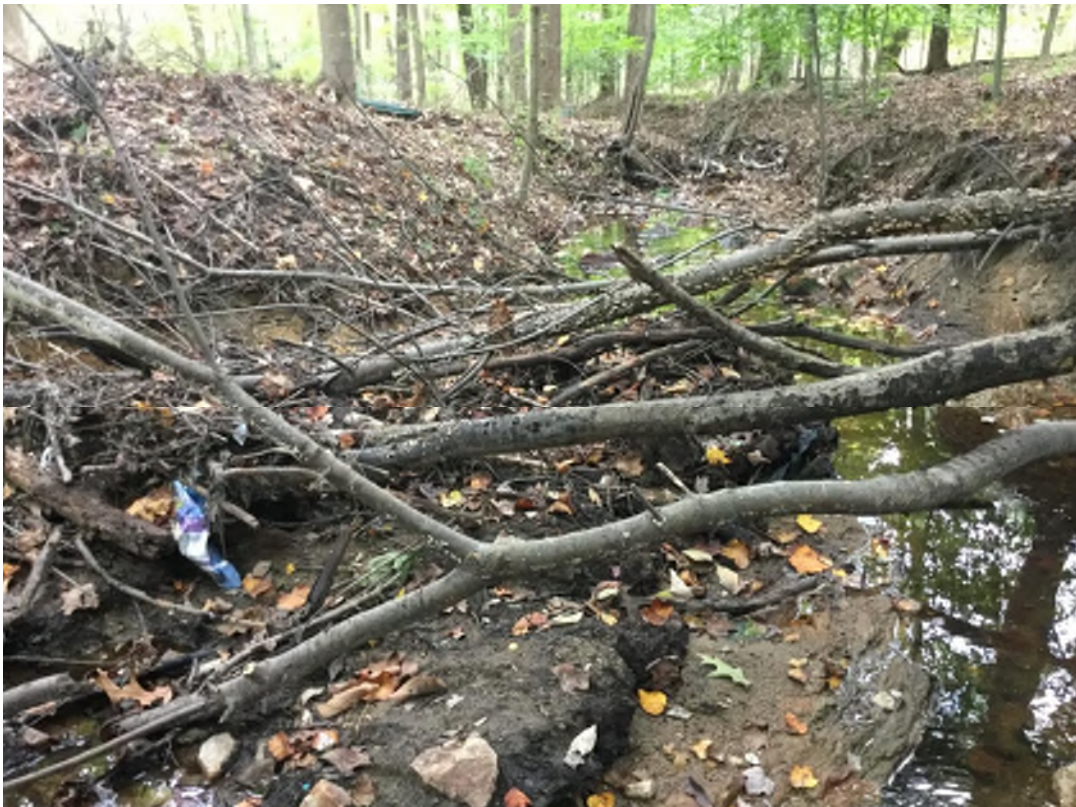
Figure 10: Debris jam in tributary 2.

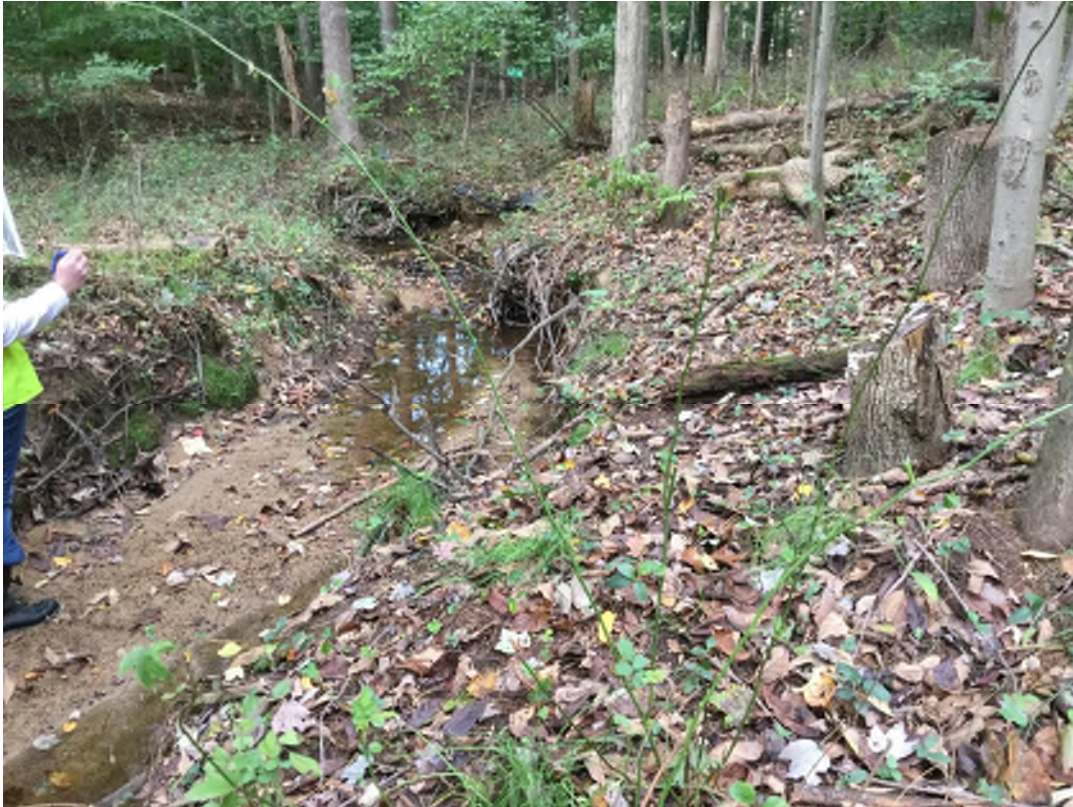
Figure 11: Bank erosion along tributary 2

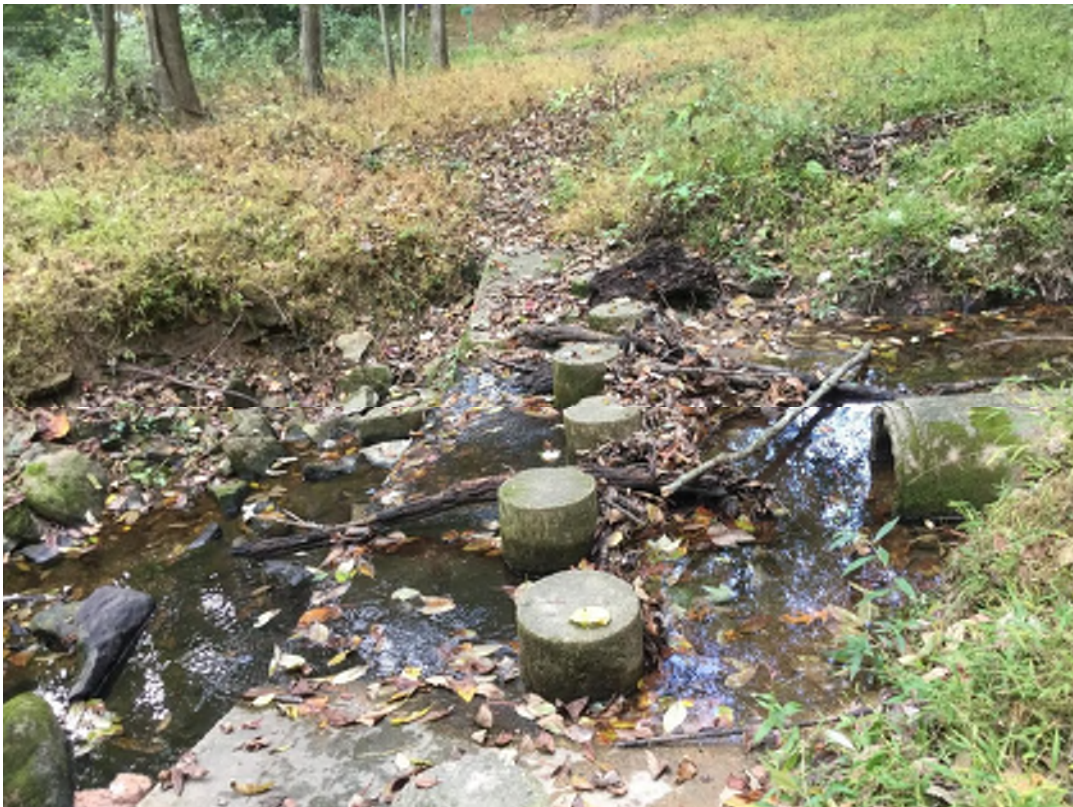
Figure 12: Concrete weir channel alteration upstream of confluence of tributary 2 with tributary 1.

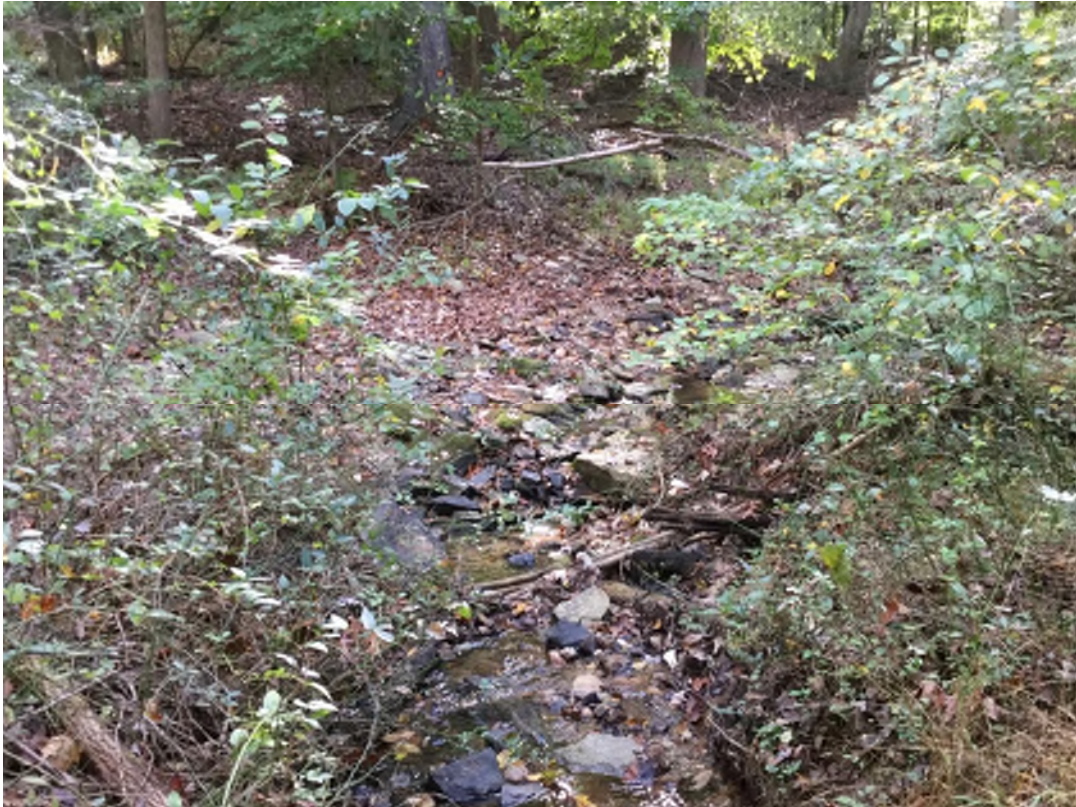
Figure 13: Confluence of tributary 2 with tributary 1. Picture of tributary 2 looking towards tributary 1.

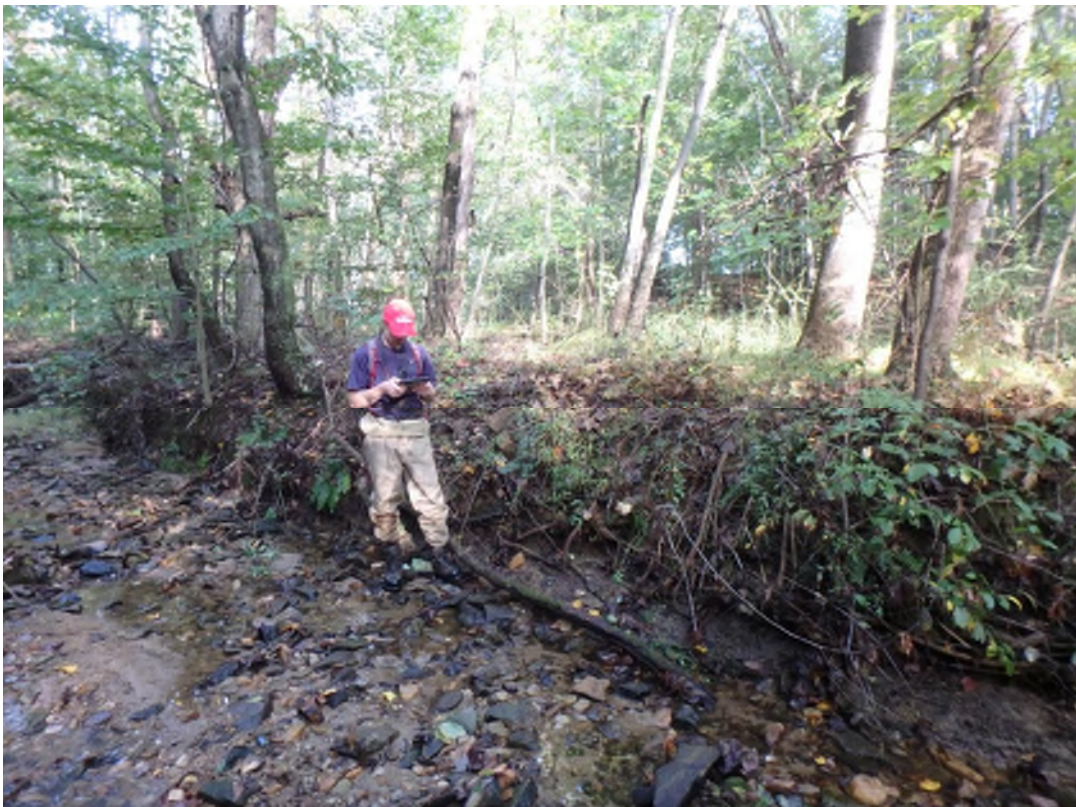
Figure 14: Tributary 1 bank erosion after confluence with tributary 2.

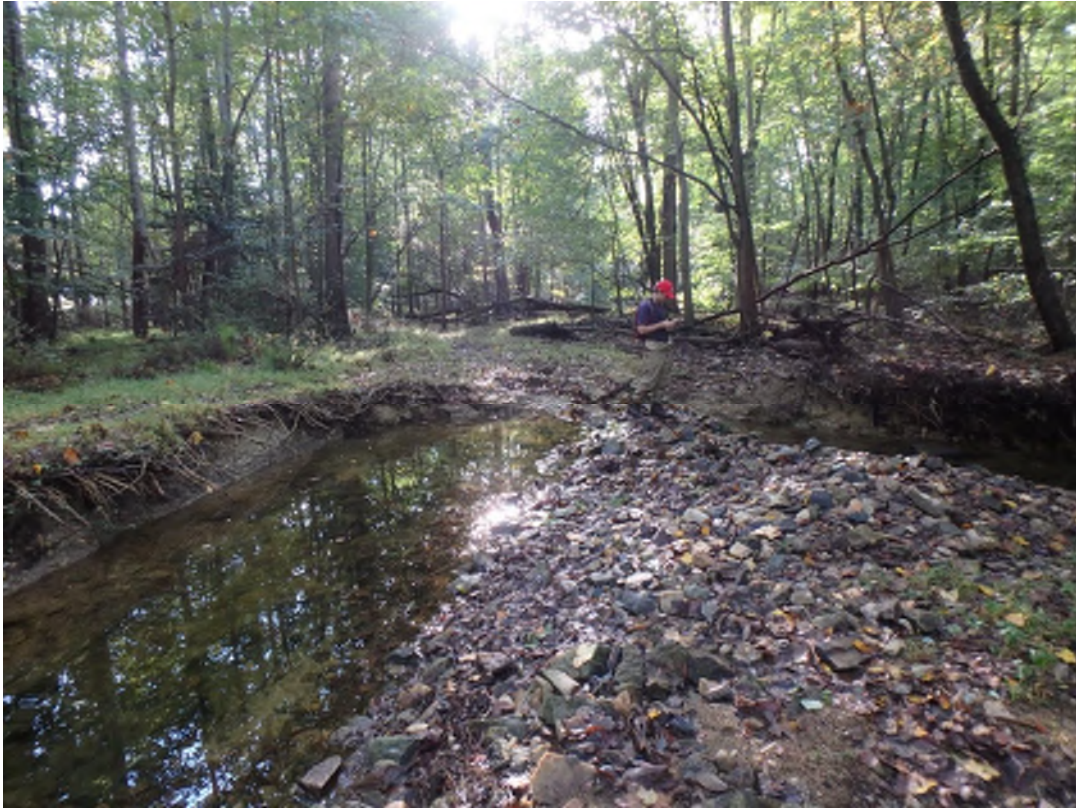
Figure 15: Fish barrier in tributary 1.
